# **INDOOR AIR QUALITY ASSESSMENT**

**Broadmeadow Elementary School  
120 Broadmeadow Road  
Needham, Massachusetts 02492**

Prepared by:  
Massachusetts Department of Public Health  
Bureau of Environmental Health  
Emergency Response/Indoor Air Quality Program  
June 2007

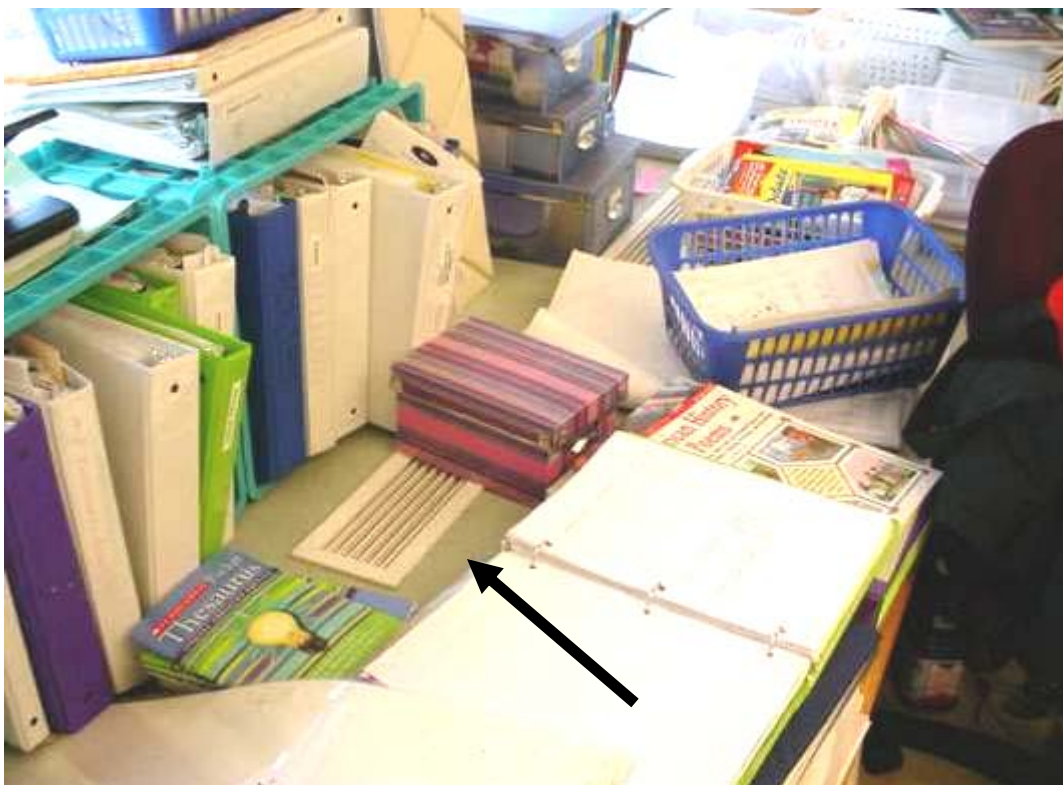
**Picture 1**

It can be seen from Table 1 that carbon dioxide levels were above 800 parts per million (ppm) in 16 of 30 areas surveyed, indicating less than optimal ventilation in about half the areas surveyed during the assessment. Mechanical ventilation is provided by rooftop air-handling units (AHUs). Fresh air is continuously distributed via wall or ceiling-mounted air diffusers (Pictures 1 and 2). At the time of the assessment, some of the air diffusers were obstructed by various classroom items inhibiting airflow (Picture 1).

**Wall-Mounted Supply Vent, Note Obstruction by Classroom Items**

5. Consider having the ventilation system balanced by an HVAC engineer every five years (SMACNA, 1994).
6. Remove obstructions from supply vents to facilitate airflow.

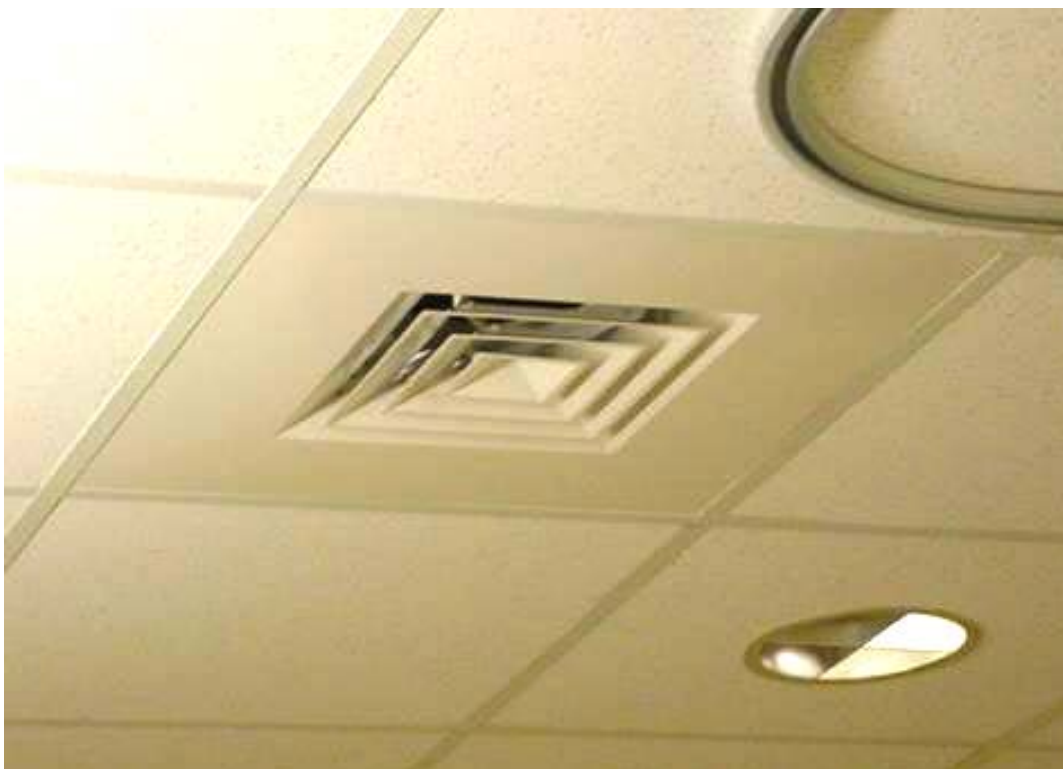
**Picture 2**

**Ceiling-Mounted Supply Vent**

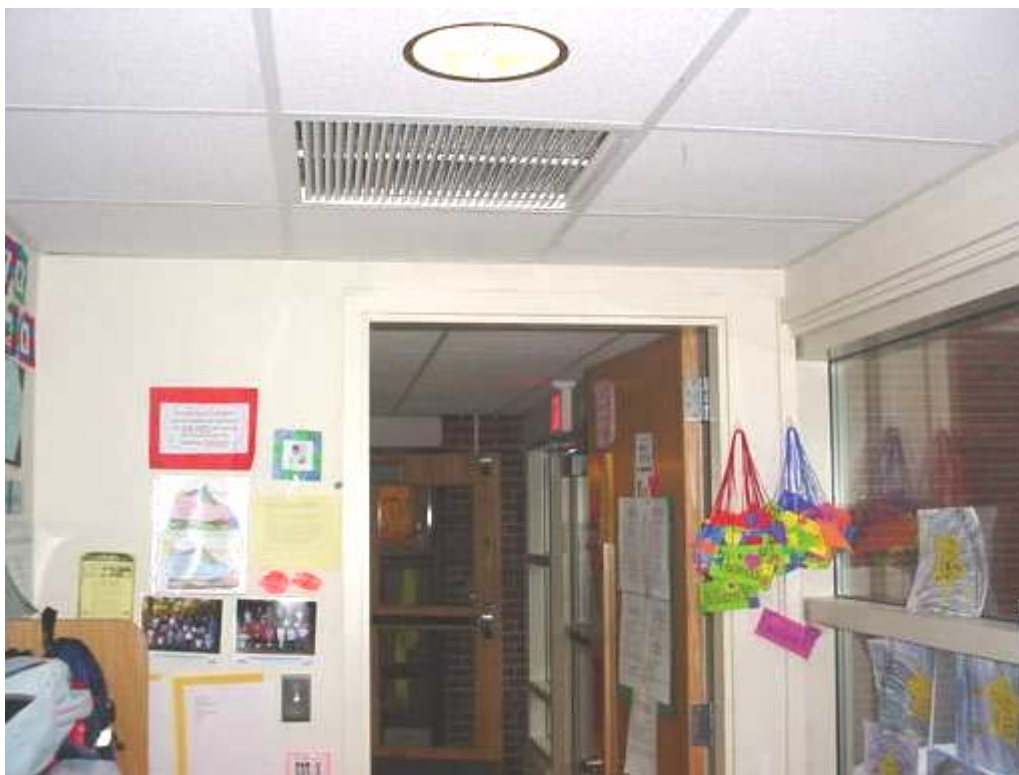
**Picture 3**

**Ceiling-Mounted Return Vent**

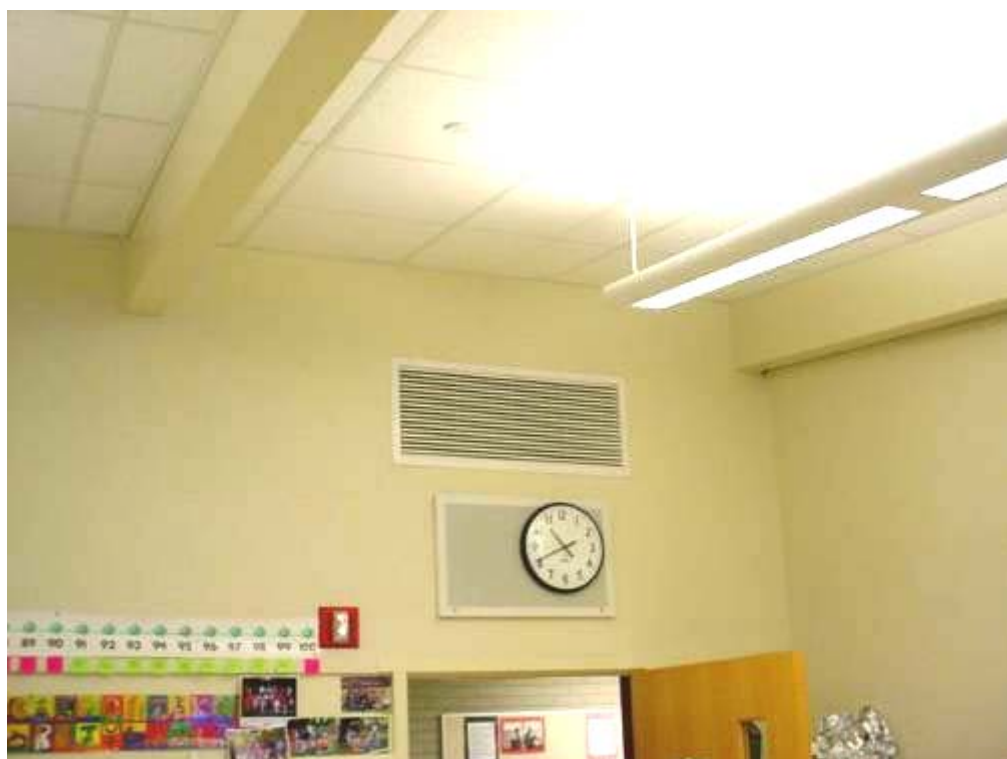
**Picture 4**

**Wall-Mounted Return Vent**

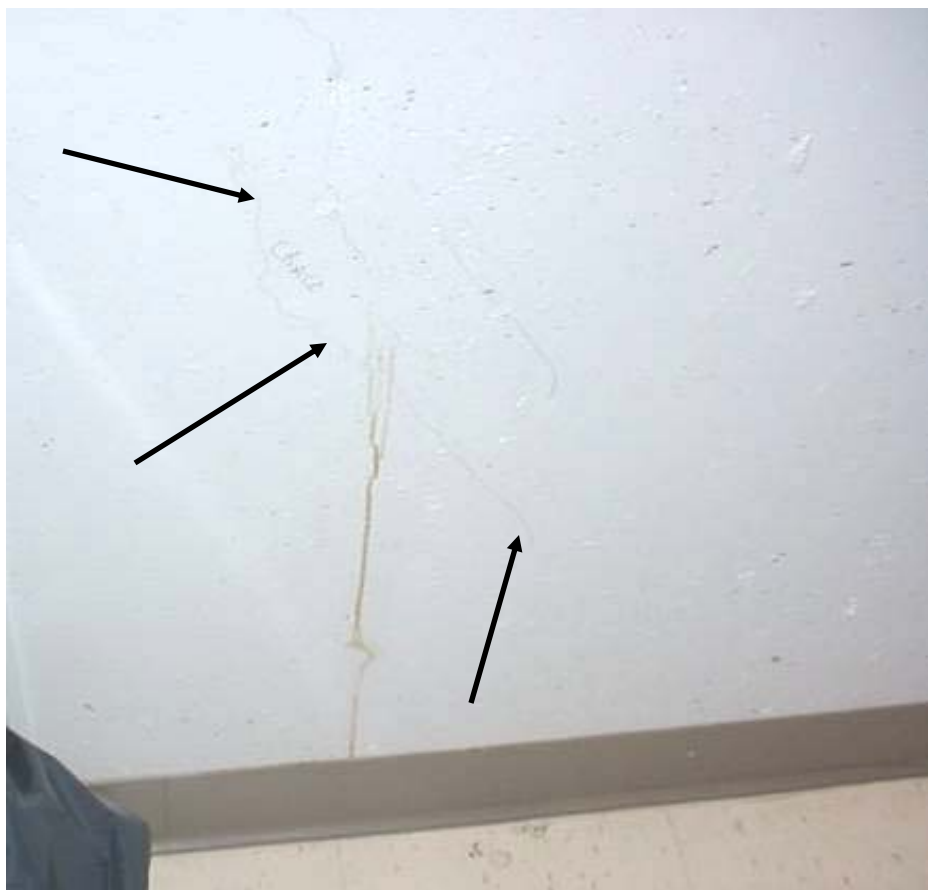
**Picture 5**

A hairline crack in the foundation was observed in storeroom 016 (Picture 5). It was reported to BEH staff that porous materials such as cardboard, paper and gypsum wallboard (GW) (Picture 6) had previously become water-damaged and colonized with mold. At the time of the assessment, the damaged GW had been removed and the area was dry and free of any visible mold and/or associated odors. In addition, porous materials were no longer being stored in this area.

**Hairline Crack in Foundation in Lower Level Storeroom 016**

10. Continue to monitor foundation crack in storeroom 016 for leakage, make repairs as needed.
11. Seal areas around sinks to prevent water damage to the interior of cabinets and/or porous building materials.

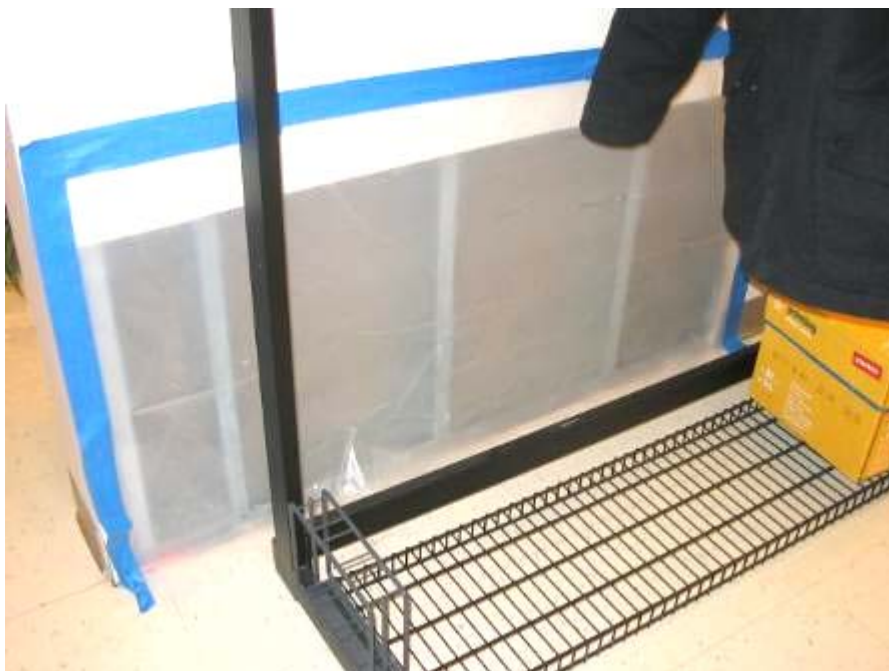
**Picture 6**

**Section of Gypsum Wallboard Removed Due to Previous Water Damage**

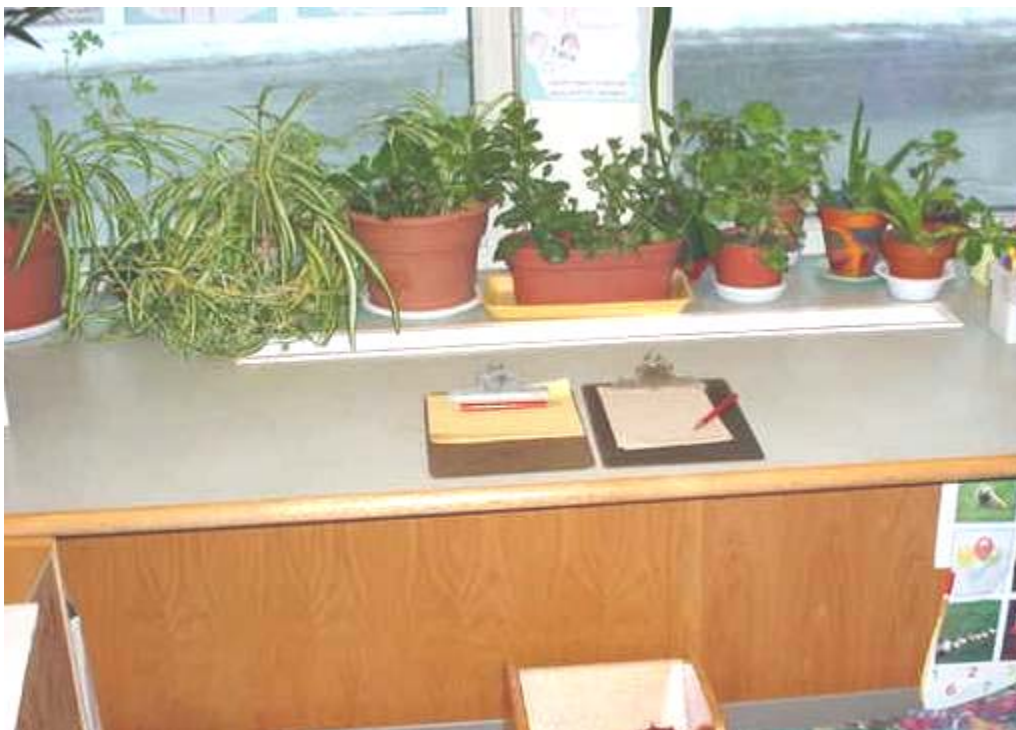
**Picture 8**

Several classrooms had a number of plants. Moistened plant soil and drip pans can be a source of mold growth. Plants should be equipped with drip pans; the lack of drip pans can lead to water pooling and mold growth on windowsills. Plants are also a source of pollen. Plants should be located away from the air stream of ventilation sources to prevent the aerosolization of mold, pollen or particulate matter throughout the classroom (Picture 8).

## Plants in the Air Stream of Ventilation Equipment

12. Ensure plants have drip pans. Examine drip pans periodically for mold growth and disinfect with an appropriate antimicrobial where necessary. Remove plants from the air stream of mechanical ventilation.

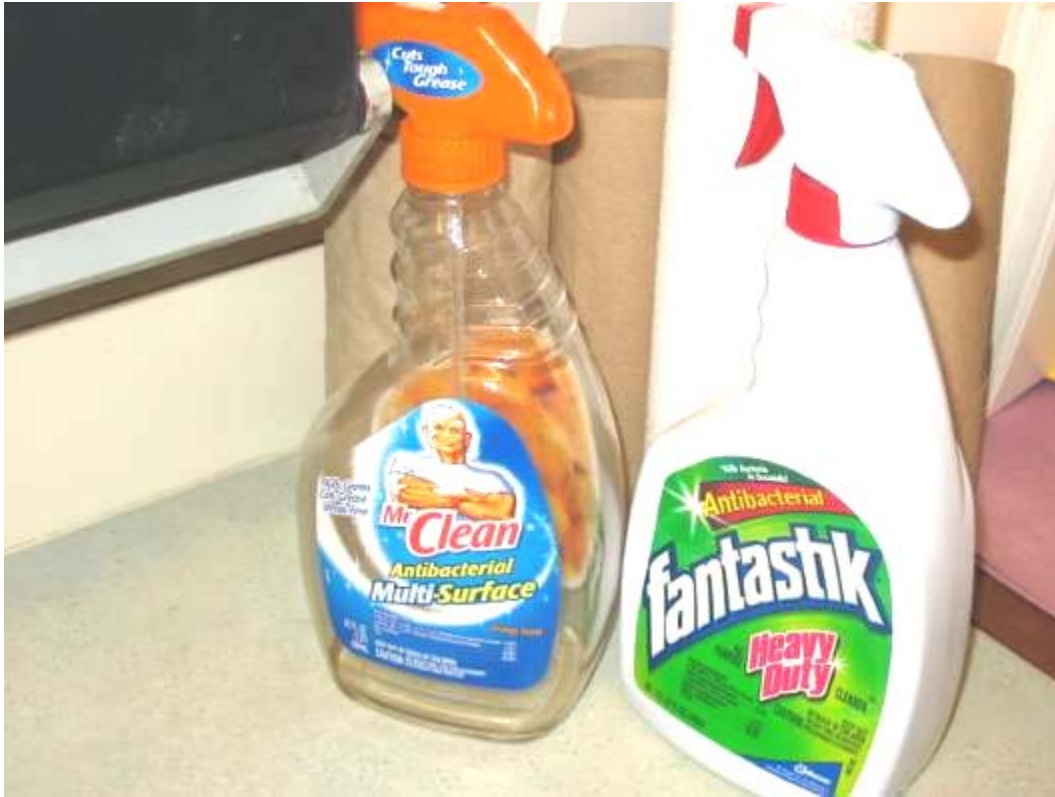
Picture 9

In an effort to identify materials that can potentially increase indoor TVOC concentrations, BEH staff examined classrooms for products containing these respiratory irritants. The majority of classrooms contained dry erase boards and dry erase board markers. Materials such as dry erase markers and dry erase board cleaners may contain VOCs, such as methyl isobutyl ketone, n-butyl acetate and butyl-cellusolve (Sanford, 1999), which can be irritating to the eyes, nose and throat. Cleaning products were found on countertops and in unlocked cabinets beneath sinks in some classrooms (Picture 9).

Spray Cleaning Products on Countertop in Classroom

13. Store cleaning products properly and out of reach of students. Ensure spray bottles are properly labeled. *All* cleaning products used at the facility should be approved by the school department with MSDS' available at a central location.
